## WATER INFILTRATION CHECK POINTS ON G5 VEHICLES

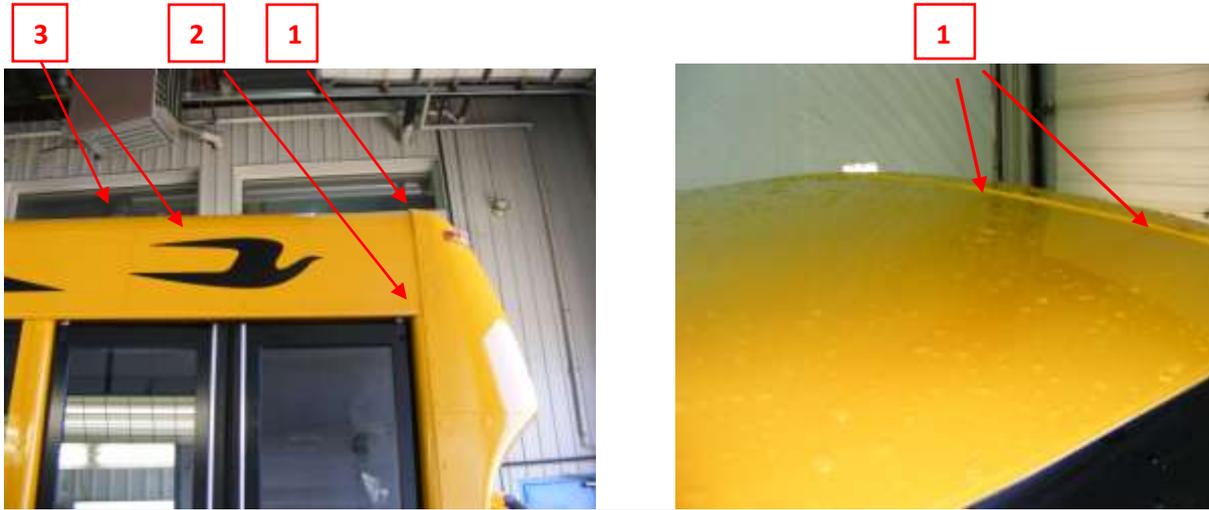
Points 1 to 7 may cause water infiltration in the roof cap that would result in water getting inside the bus, over the driver or on the front corner of the entrance door.

1. On top of bus, check for cracks or unsealed areas where the roof cap meets the roof skin. At the front of the bus as well as at the rear. **Because of the G5 ergonomics, it is possible that a rear leak will result in water spots in front of the vehicle.**
2. On both sides of bus, check the seam **especially** where the gutter ends.
3. On both sides of bus, check along the black corner of bus for missing sealant.
4. If an additionnal gutter has been installed on bus, check on the side for holes.

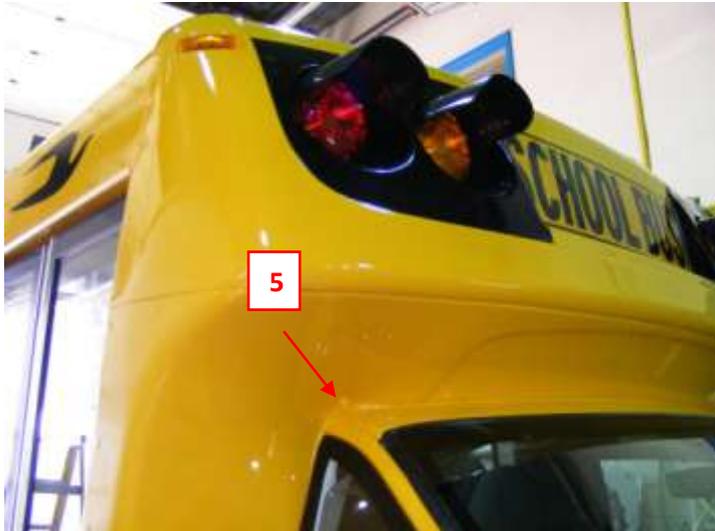
5. Look for missing sealant where roof cap meets cabin above windshield.

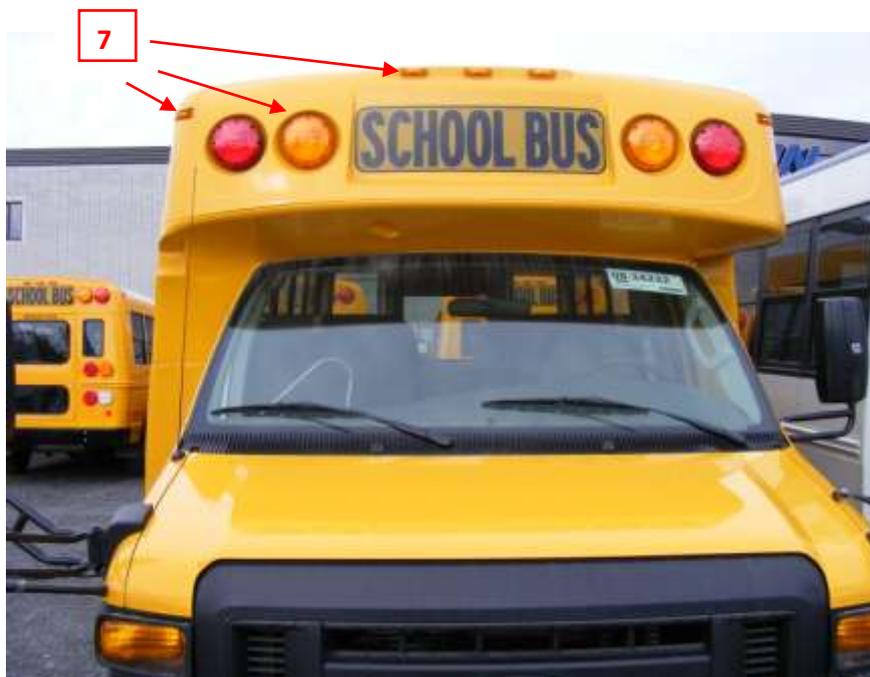
6. Check for any accessories on top of the bus to ensure they are tightly installed and are well sealed. (A/C condensers, PA systems, Strobe lights, Roof hatch...)

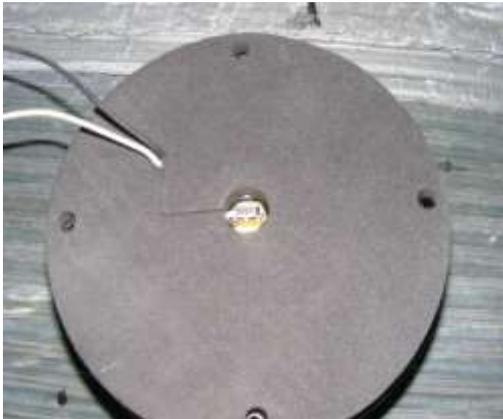
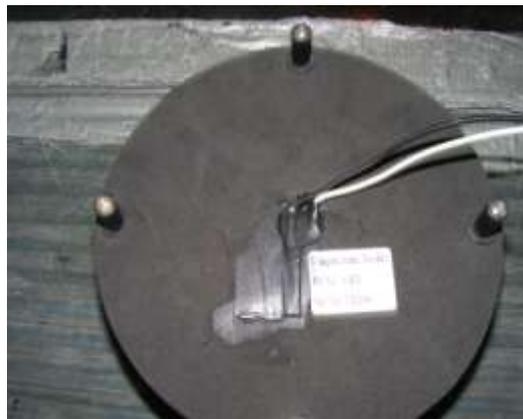
7. If everything has been well sealed and water is still infiltrating, then you might want to check the marker and warning lights. (If the vehicle has light hoods, you may add sealant to the screw holes)

We suggest that you remove the 8 way lights and:

- a) Bring the wires towards the center and fill the inner hole with sikaflex as shown on following picture. Draw a circle of sealant around the wire hole on the roof cap. Make sure inserts are secured onto screws and are not damaged, replace if necessary.
- b) When lights are put back in place, all screws need to be correctly tightened to ensure the insert is properly engaged and offers a good water barrier. If a new light is put in, make sure to put sealant on top of cut off in light gasket and in the wire hole.

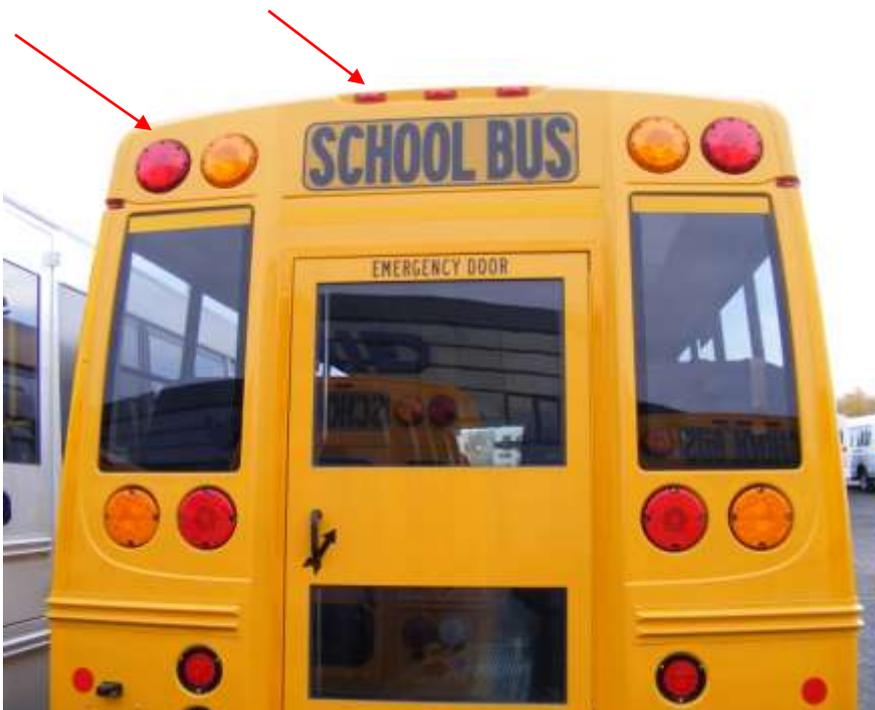
If water comes in the areas at the **bottom corners of the back windows**, check if all lights are well secured and sealed.
