CHECK POINTS FOR WATER INFILTRATION ON MICRO BIRD MBII VEHICLES

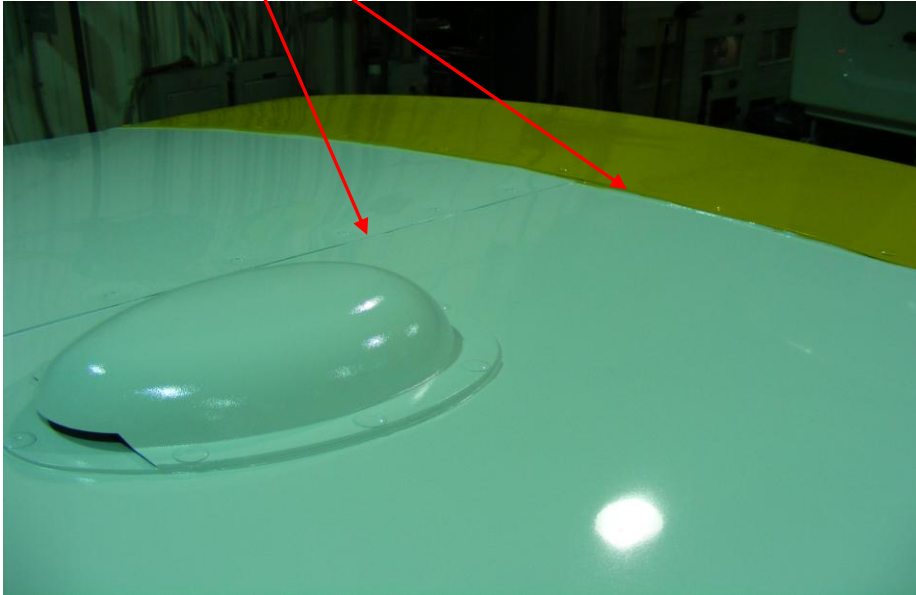
1- Check Roof Seams.

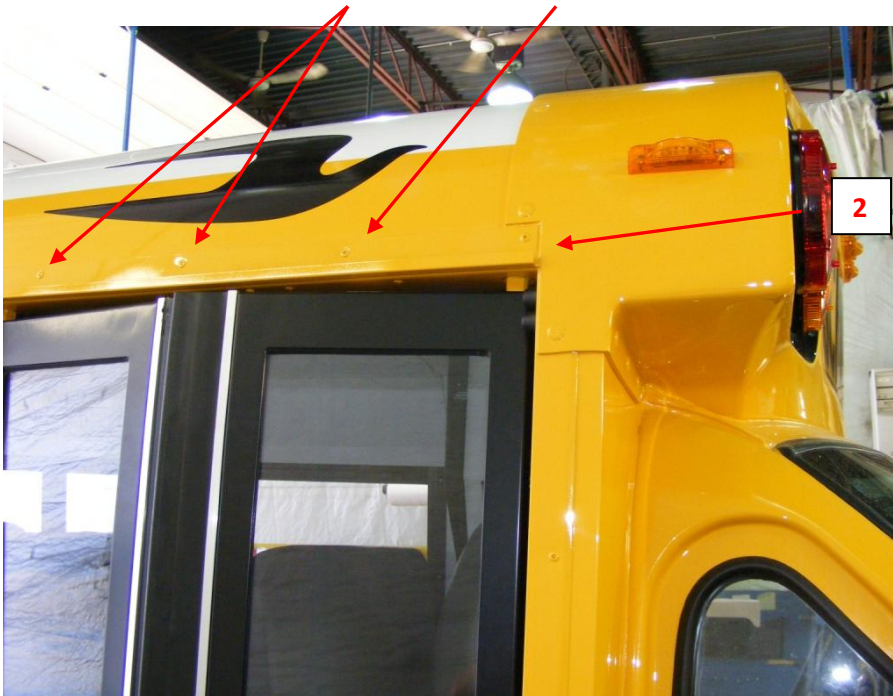
2- Check seams of roof cap in front of gutter on both sides of bus. If sealant is cracked, or has a pin hole, take off sealant at the end of the gutter and put new sealant making sure to fill the space under the roof cap.

3- Check top of steel gutter, corner and rivet on both sides of bus.

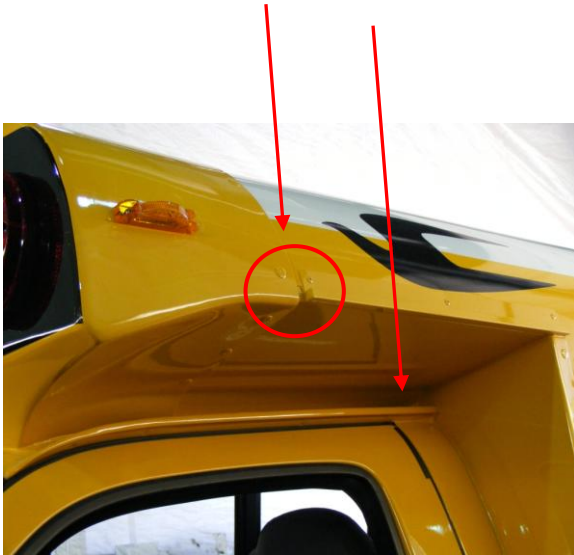
4- Make sure area where the roof cap meets the cab is well sealed.

And check end of gutter.

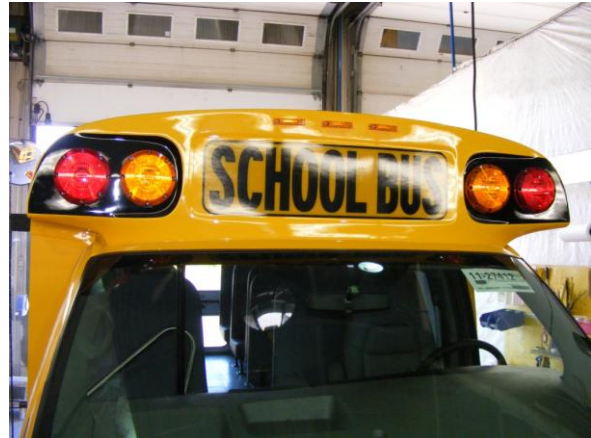
5- Check for loose lights. (If the vehicle has light hoods, you may add sikaflex to the screw holes.)

Make sure inserts are secured onto screws and are not damaged, replace if necessary.

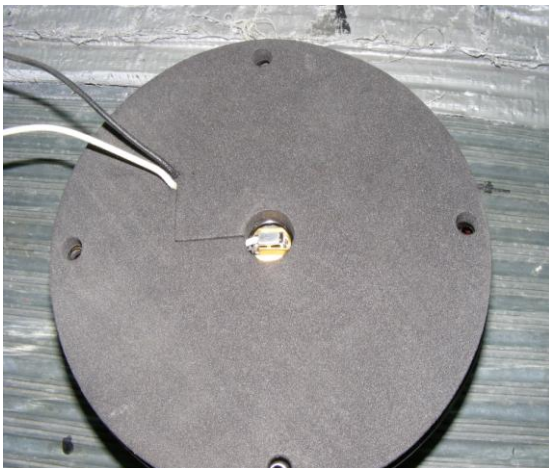
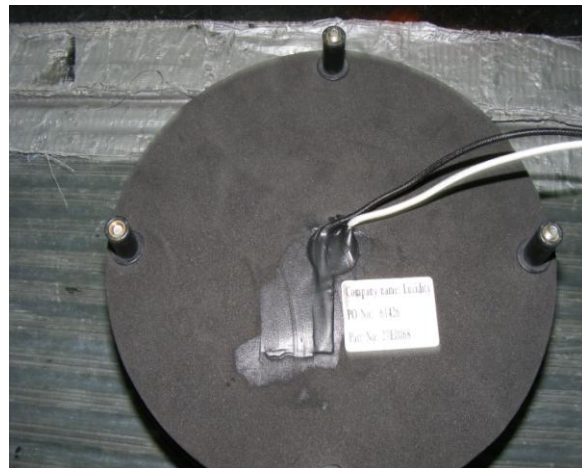
6- When lights are reinstalled, all screws need to be correctly tightened to ensure the insert is properly engaged and offers a good water barrier. If a new light is put in, make sure to put sealant on top of cut off in light gasket and in the wire hole.
